Cape Hatteras Light Station Cultural Landscape Report

Cultural Landscape Report

Prepared by Susan Hart Vincent
Historic Land Design
Charlotte, North Carolina

2003

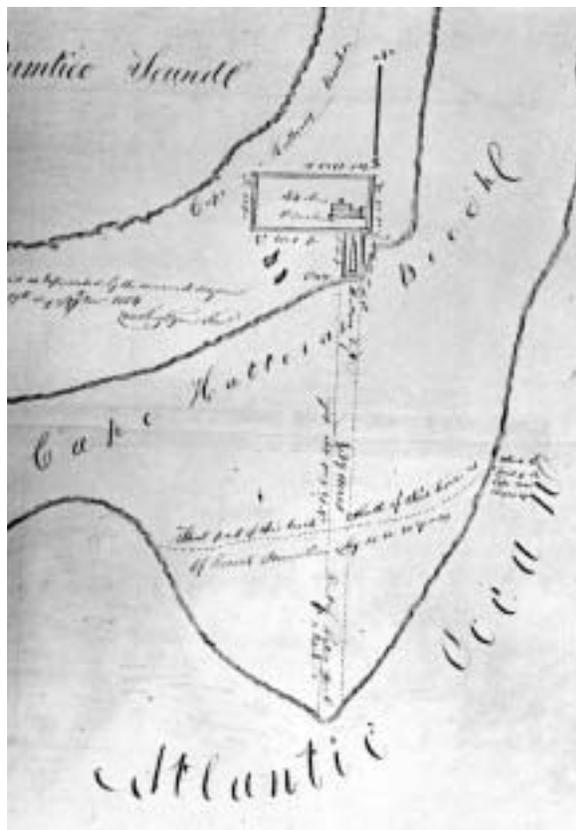
FIGURE 2. Cape Hatteras Light Station Survey of November 29, 1854, showing the 4-acre original tract and the 1828 40-acre tract, as found in Holland, 1968.

The 1854 survey in figure 2 illustrates the quarters north of the lighthouse and within the forty-acre tract purchased in 1828. Although not shown in the survey, a smokehouse may have been built along with other necessary outbuildings.¹²

The survey showed the boundaries of the reservation enclosing a square area of approximately 40 acres. How the property holdings changed from forty-four acres to forty acres is not known. Bamber's boundaries are incongruous with the 1854 map in figure 2.

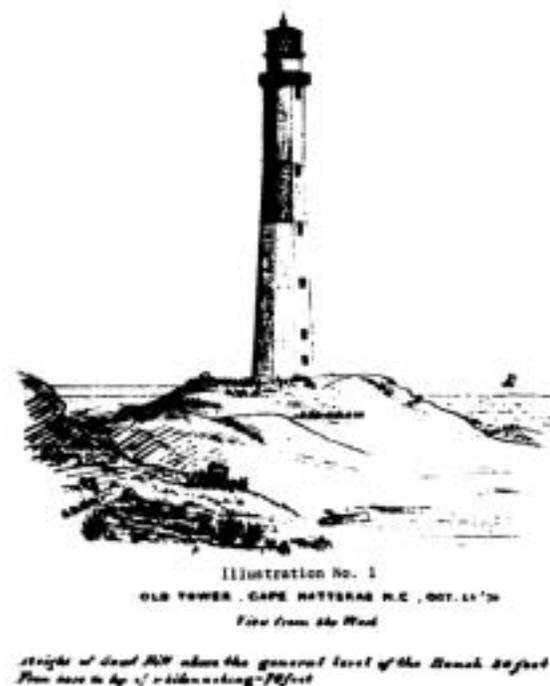
FIGURE 3. Nicholson's Sketch of the Old Tower, Cape Hatteras, NC, October 24, 1870, showing the height of the original tower and the 1854 addition.

In 1854, Congress appropriated \$15,000 for refitting the light and raising the tower to 150 feet. The addition was made of brick and housed a first order fresnel lens. At the same time the tower was painted white for the first seventy feet and red for the remainder. The red and white day mark would improve sailors' ability to see the tower during the morning and afternoon hours.

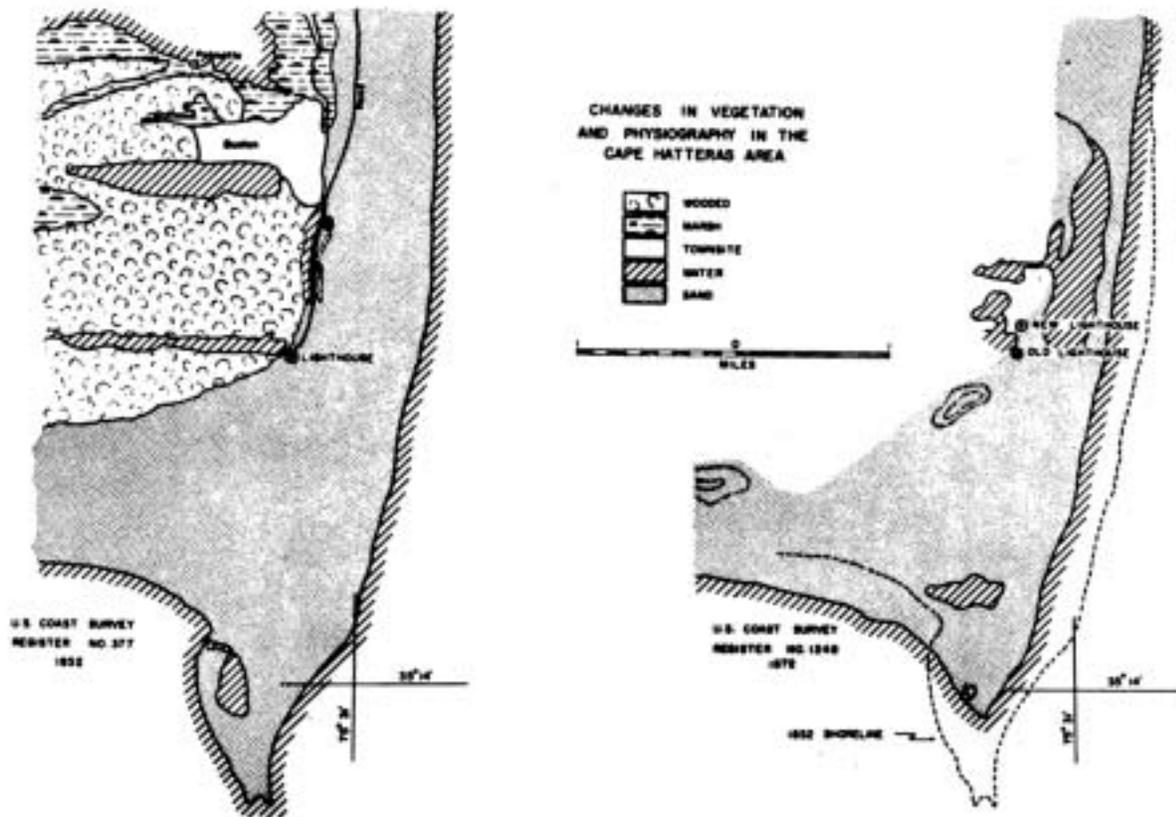
FIGURE 4. Physiographic changes in the Cape Hatteras area, 1852 - 1872.

of the light station. Another north-south pond ran parallel to the lighthouse road approximately one-half mile to the north. This pond may have been associated with Cape Creek, the eastern boundary of the station property (formerly Farrow's) that drained north to the Pamlico Sound. By 1872, the north-south pond had moved east and enlarged, leaving a thin piece of land between it and the ocean. The linear east-west pond also appears to have enlarged (fig. 4).

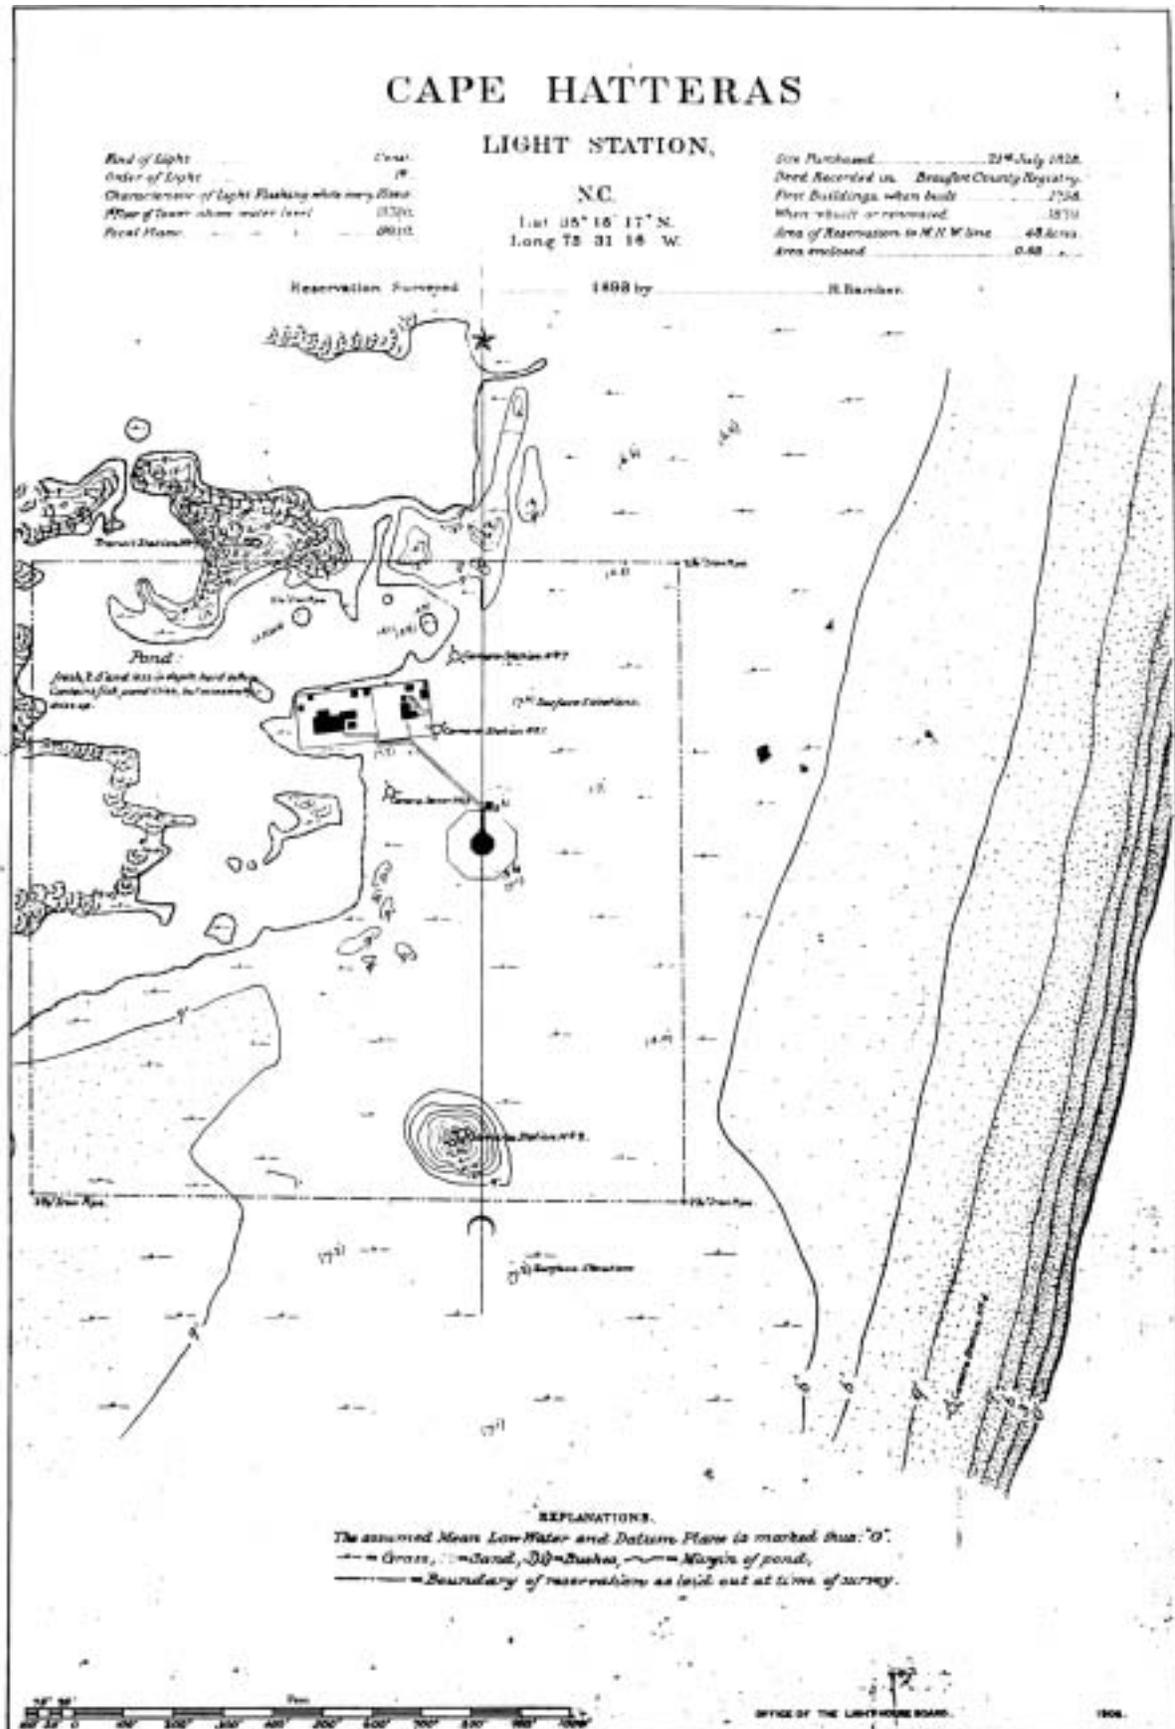
FIGURE 5. H. Bamber's 1893 Survey of Station Boundaries and Shore Line.

The 1870 light station was surveyed in 1893 by H. Bamber for the Office of the Lighthouse Board (fig. 5).

Despite the optimism of this report, the shoreline erosion near the lighthouse was increasing. The 1893 Bamber survey (fig. 5) indicated the water had moved to within approximately 1,300 feet of the new tower. In addition, photographs of the same period show a flat, open sandy beach south and southwest of the tower. In 1919, a low sand ridge, remnant of an old dune line, ran parallel with the shore about 500 feet east of the light. Soon after, the ocean overcame the dunes and washed to within 300 feet of the lighthouse.

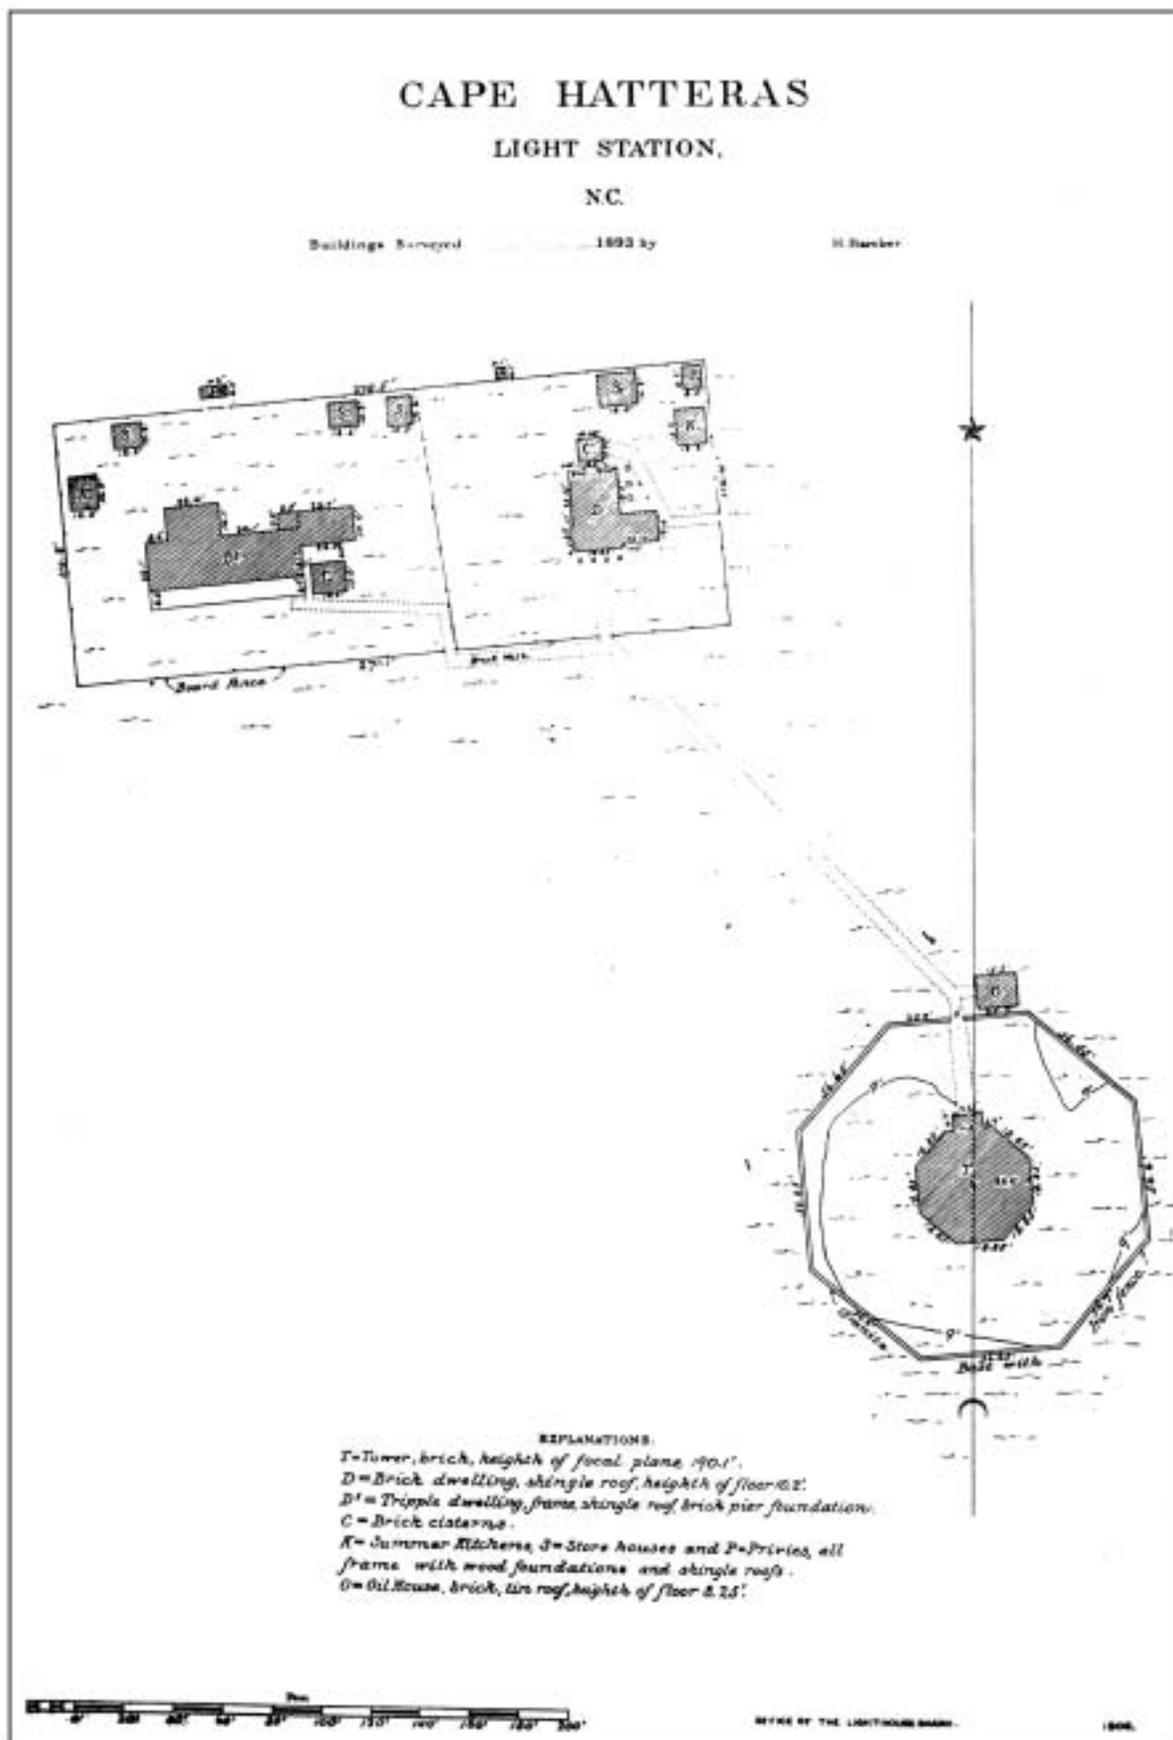
FIGURE 6. H. Bamber's 1893 Survey of Cape Hatteras Light Station, NC.

summer kitchen, three storage structures, a cistern, and double privy (fig. 6). All structures were painted white.

Although historical sources cite 400 feet of new fence being built, it appears that approximately 900 feet were needed to construct the white board fence that surrounded both dwellings in 1893 photographs.²⁰ The fence was approximately 110 by 270 feet, with a 110-foot segment dividing the two properties (fig. 6).

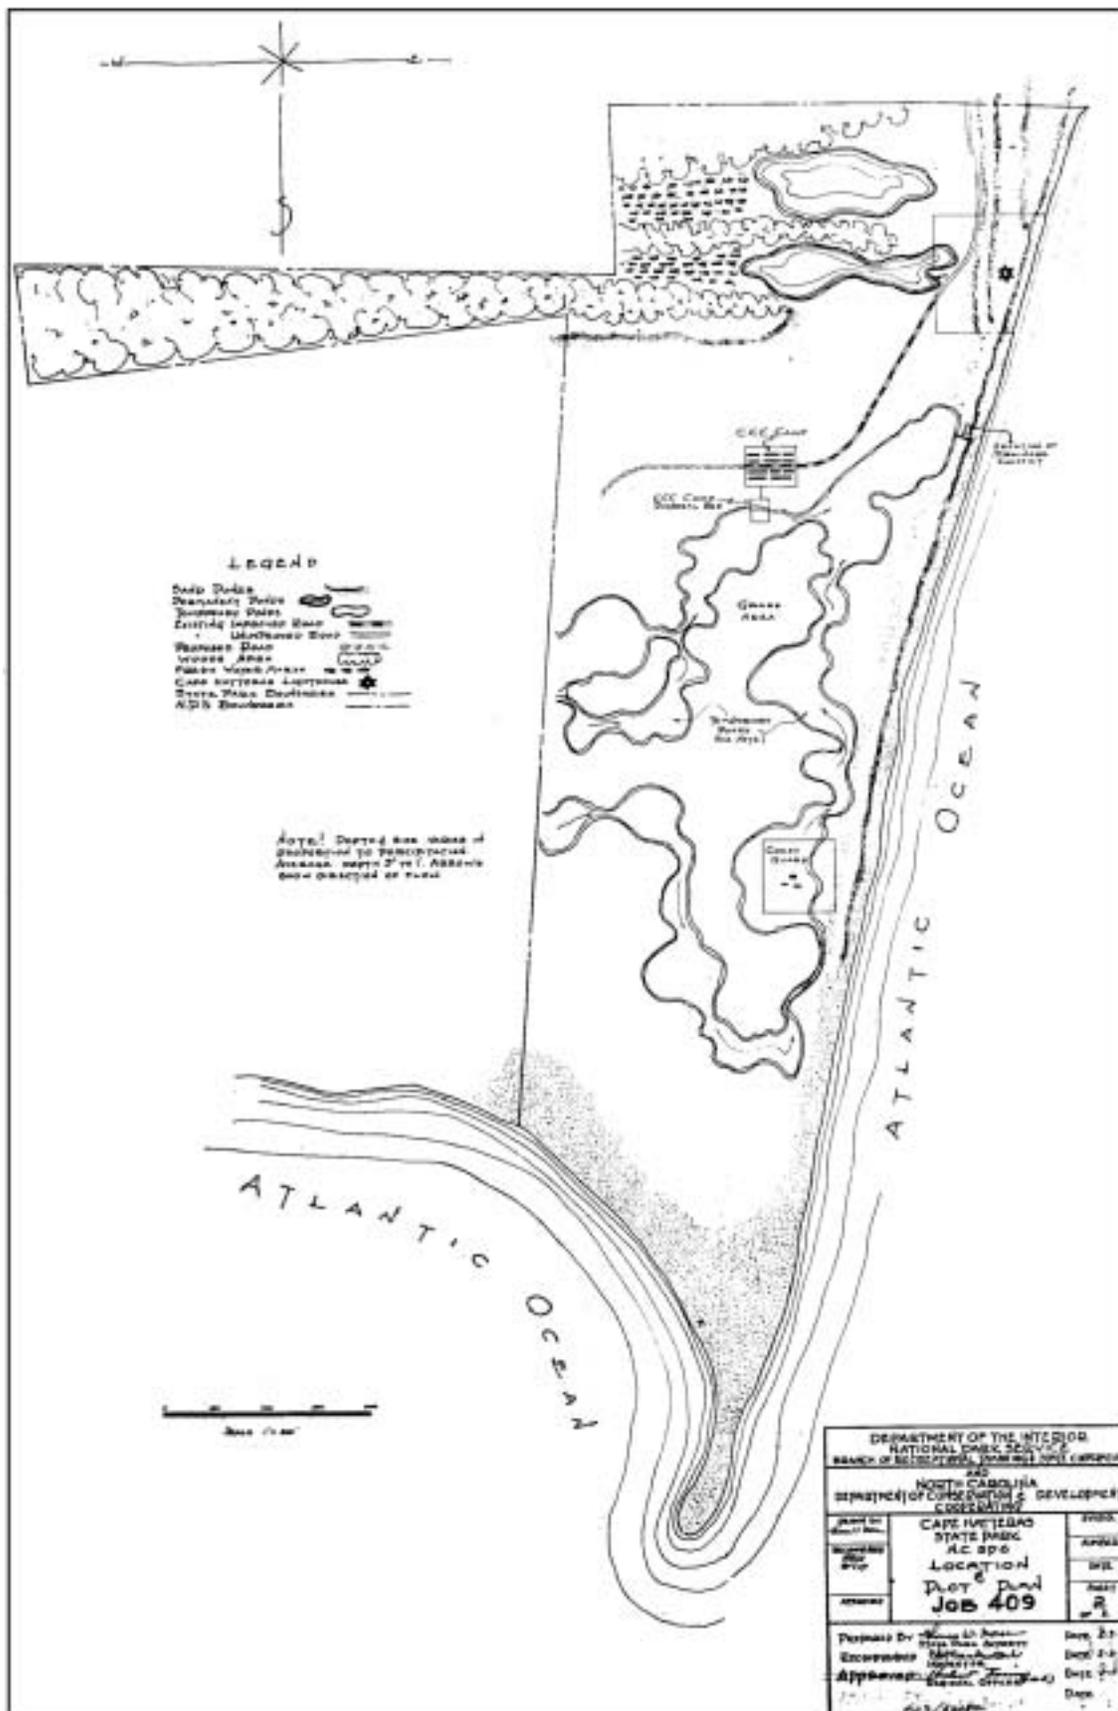
FIGURE 8. Cape Hatteras State Park, N.C. SP-6, 1937 Location and Plot Plan.

Cape Hatteras State Park, or Phipps Memorial State Park, was originally owned by the John Phipps and Henry Phipps families. The date of inception is not known, nor has information been located to indicate the type of facilities present. The state park included approximately 1,400 acres and surrounded the Cape Hatteras Light Station to the north, west, and south (fig. 8).

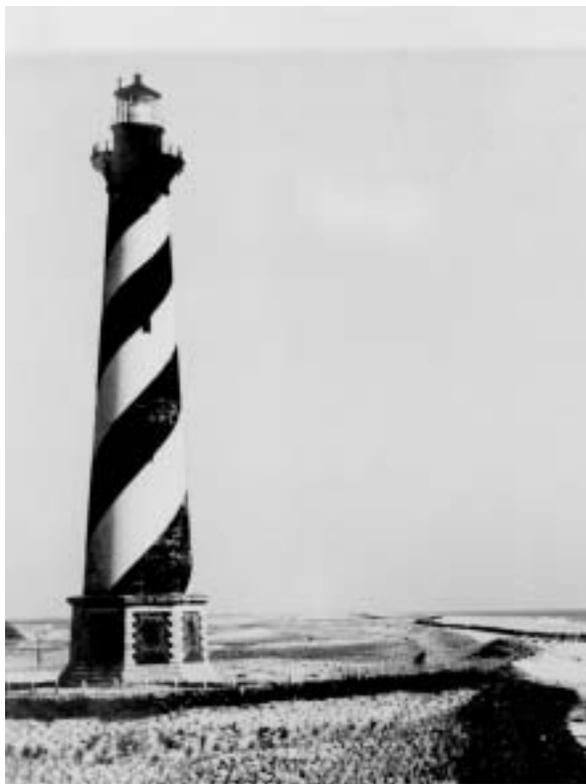
FIGURE 9. North view of Lighthouse and CCC brush fences and grass plantings. Lighthouse revetments can be seen along the beach, ca. 1935.

CCC efforts to save the lighthouse resulted in the construction of a series of wooden revetments and sand fences to check erosion (fig. 9). Sand fences constructed both in front of and behind the lighthouse lowered wind velocity and allowed dunes to form. By 1937, the dunes had reached "considerable height." Shoreline erosion eased somewhat afterward, but the ocean was only 600 feet from the tower.

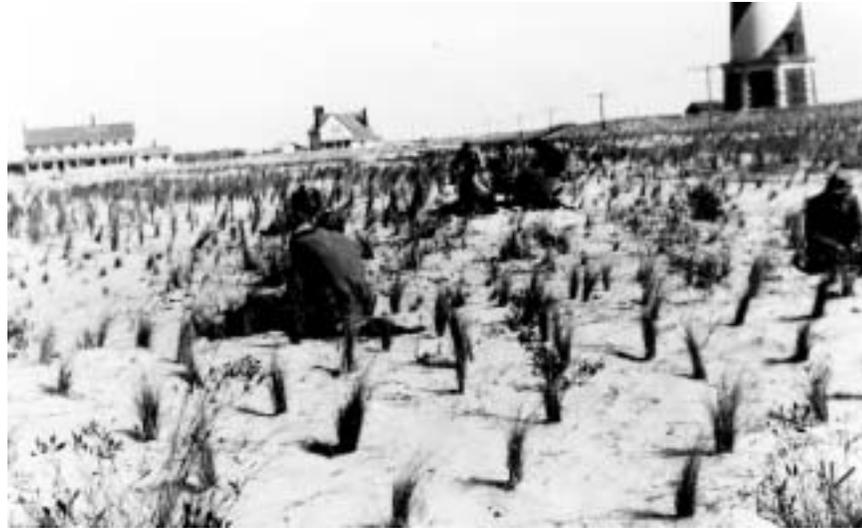
FIGURE 10. CCC grass planting, ca. 1935.

At Cape Hatteras State Park, CCC workers installed four miles of brush fences. Native grasses planted on twenty-two acres of dunes took root and began collecting sand. Approximately 18,000 shrubs and trees, including yaupon, American beauty bush (*Callicarpa americana*), loblolly pine (*Pinus taeda*), redbay, live oak, and wax myrtle were planted on nearby sand flats (fig. 10).²⁷

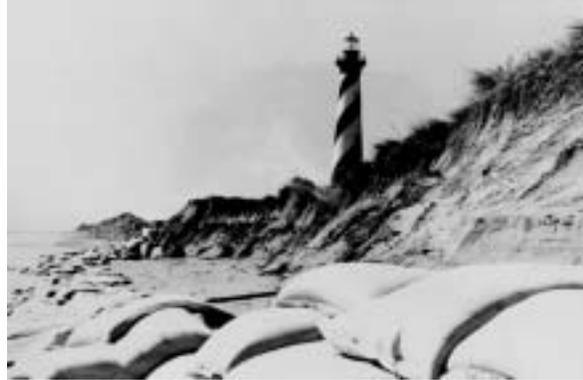
FIGURE 12. Sandbagging efforts in 1968 to protect the lighthouse.

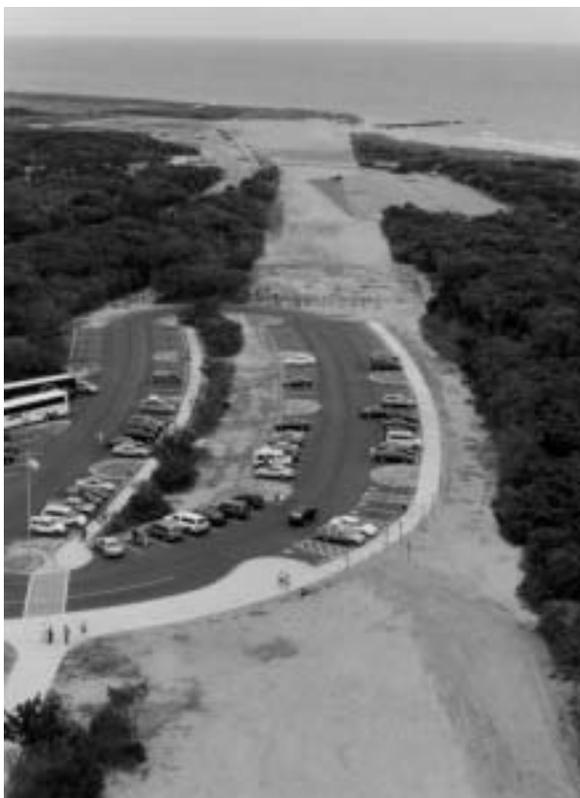
FIGURE 14. Northeast view of move corridor and old lighthouse site, May 2001.

Once all the structures were relocated, ICC removed the tracks and any debris that resulted as a byproduct of the move. The move corridor was back-filled and re-graded to resemble pre-move elevations (fig. 14).

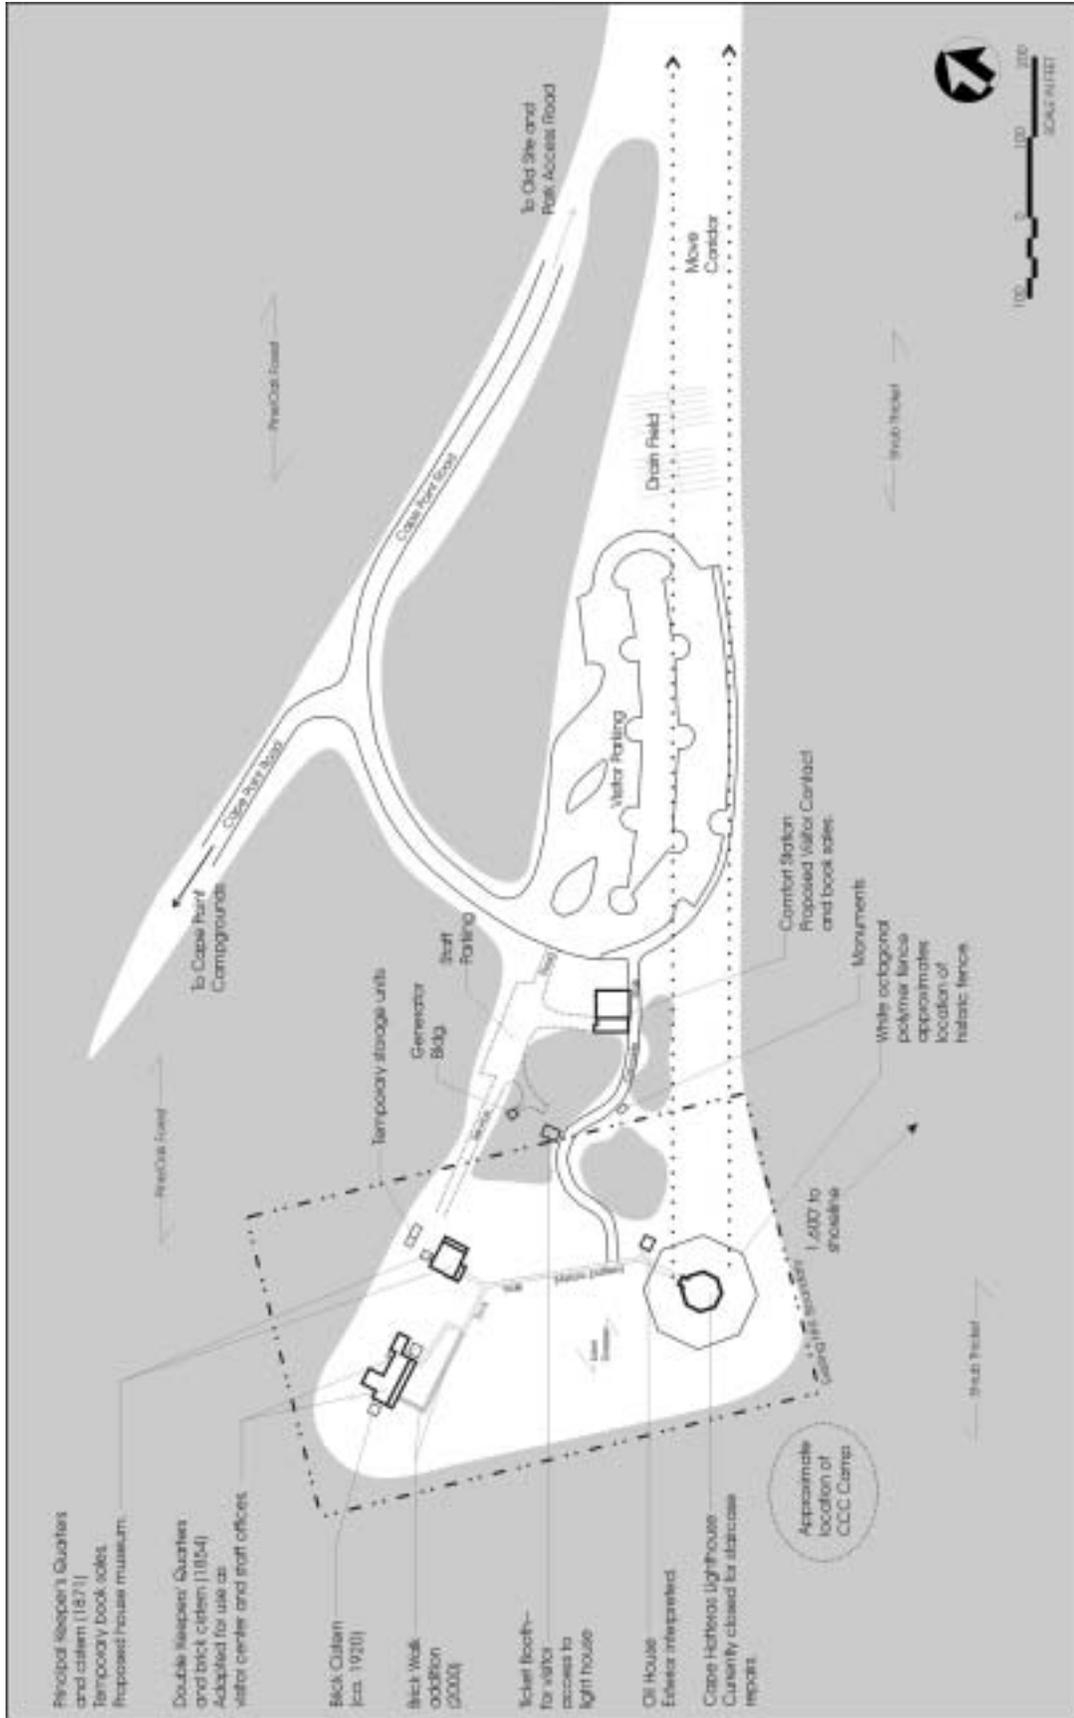
FIGURE 15. Existing Conditions Plan.

Existing conditions reflect the ongoing development of the site (fig. 15). Three phases of development were planned, of which two have been realized. Phase one involved the preparation and relocation of the light station complex to its new site. Phase two, completed in 2001, provided for site visitation and included the construction of a light station access road, a visitors parking area, a comfort station, a temporary ticket booth, and walkways. Clearing away trees in the historic zone and planting lawn grasses was also completed in this phase.

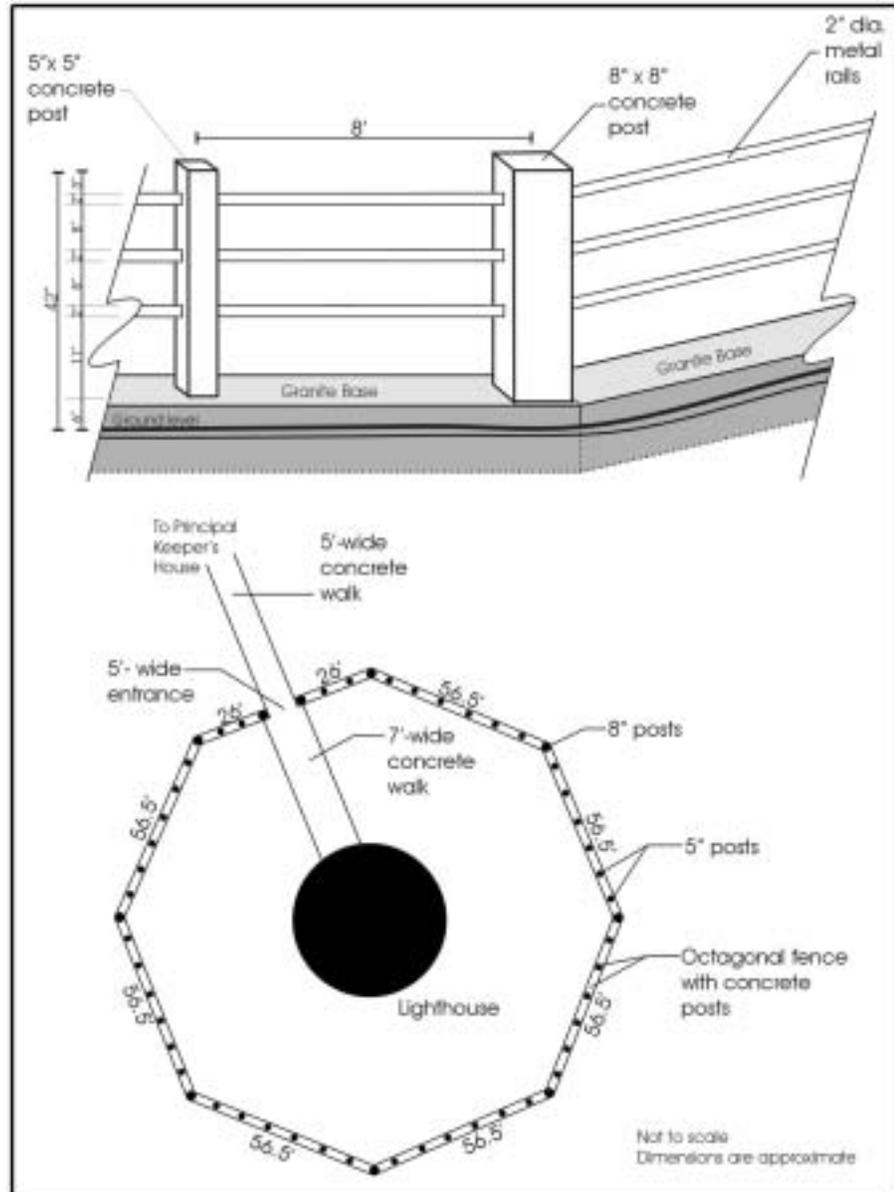
FIGURE 17. Lighthouse Fence Details.

- Maintain the exterior of extant keepers' quarters and cisterns white, which is consistent with the end of the historic period.
- Restore the historic concrete post and metal rail fence that surrounded the lighthouse at the end of the historic period. Use the original granite stones that supported an octagonal fence there throughout the historic period (fig. 17).
- Restore the historic concrete post and wire fence that surrounded the principal and double keepers' quarters at the end of the historic period. This is consistent with the period of significance in that a rectangular fence surrounded the quarters from 1888 to ca. 1950. Nine hundred yards of four-foot-tall welded wire fencing, with 8-inch-by-12-inch rectangles, can be specially made for approximately \$500 (fig. 18).²

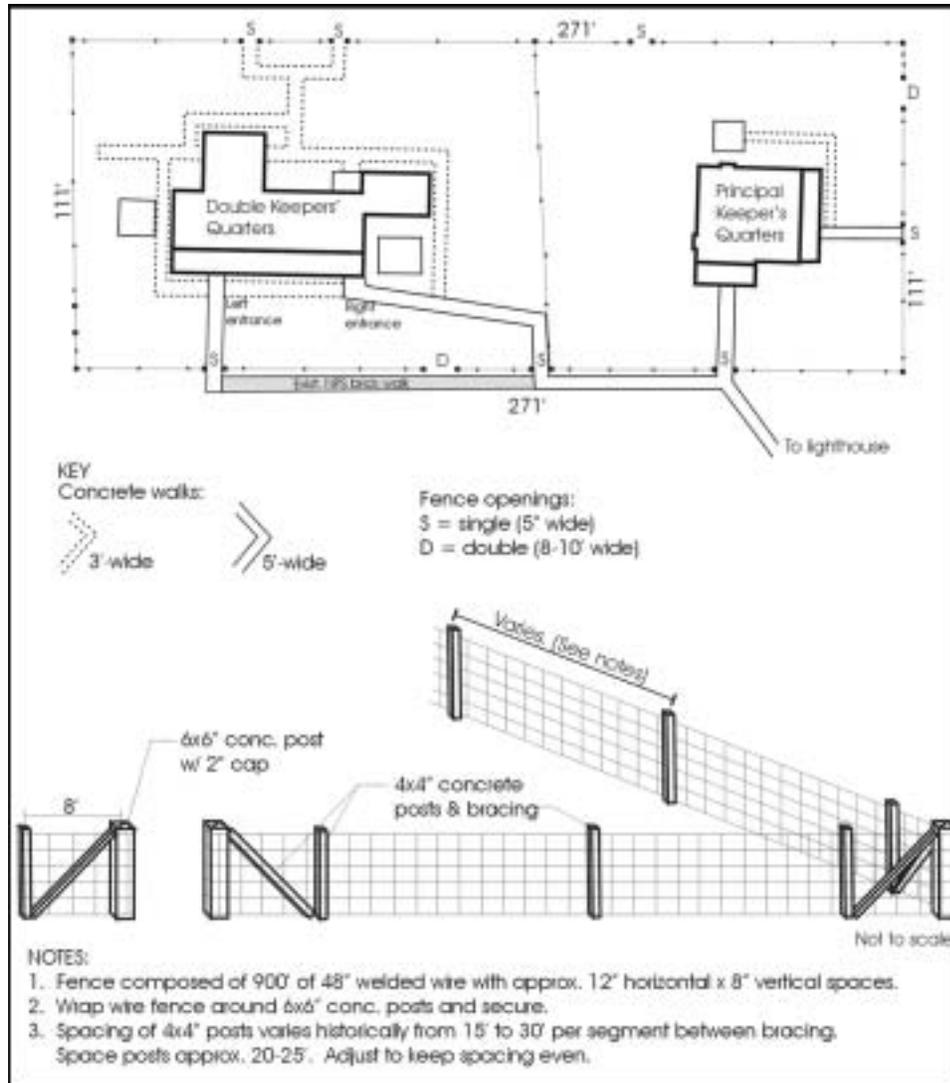
FIGURE 18. Keepers' Quarters Fence and Walk Details.

- Restore a five-foot-wide concrete walk from the east door of the principal keeper's house to the proposed fence. This walk is a visual contribution to circulation patterns and not to be used as a visitors entrance. Therefore, elevation changes to meet ADA requirements are not necessary (fig 18).
